HISTORIC STRUCTURE REPORT

VOLUME II

COIT TOWER SAN FRANCISCO, CALIFORNIA

April 1989

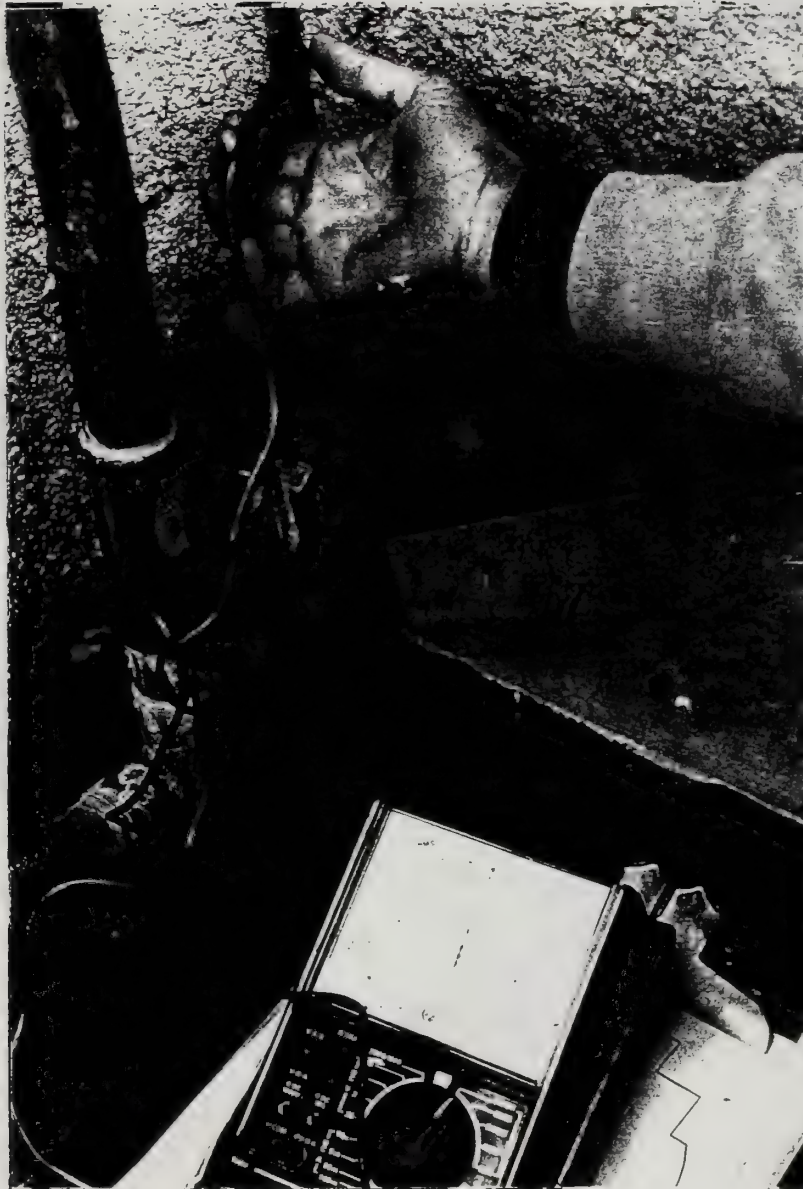
PHOTO I
Moisture indicated behind a different
construction joint.

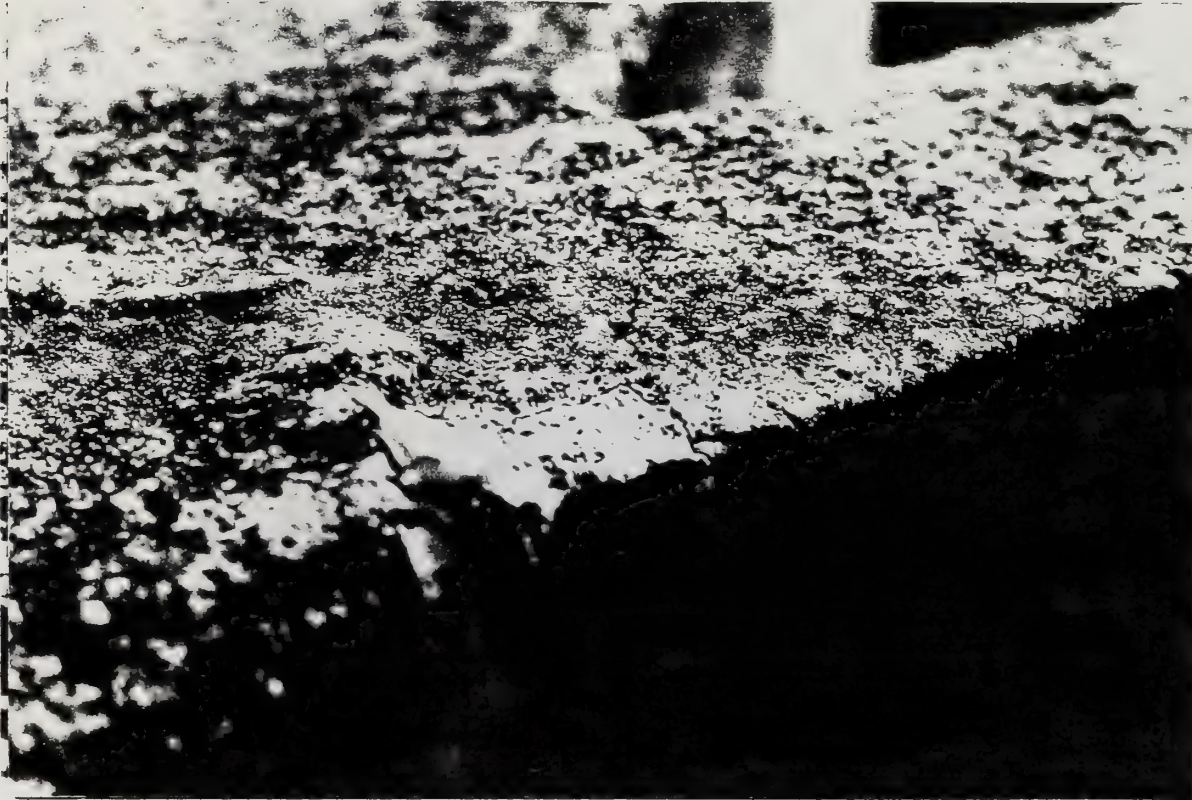
PHOTO J
Crack in plaster surfacing above
area of Photo I.

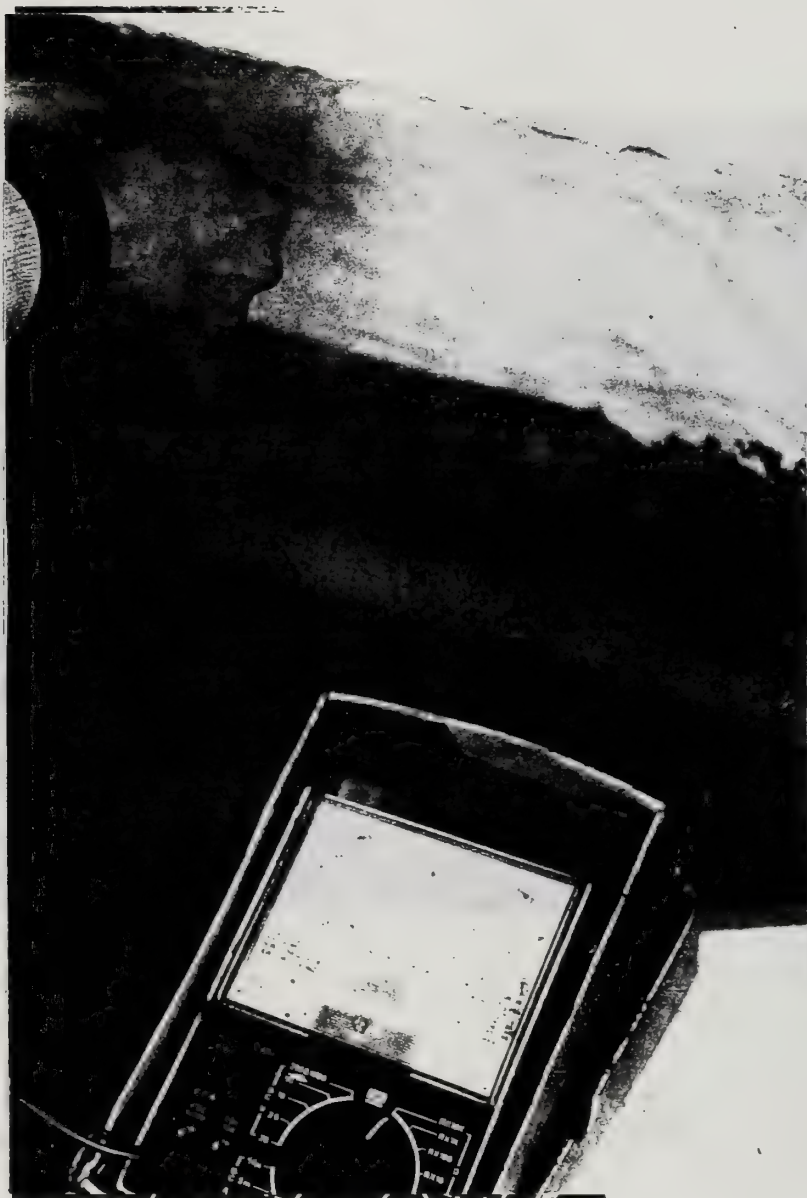
PHOTO K
Moisture indicated in plaster behind
elastomeric wall coating.
